**Flood Control Project Maintenance
Levee Inspections**

Fall 2013 Levee Maintenance Deficiency Summary Report

Yolo County Service Area 6

Waterway	Bank	Unit Miles
Unit No. 01 Right Bank of Sacramento River at Knights Landing	Right	5.97

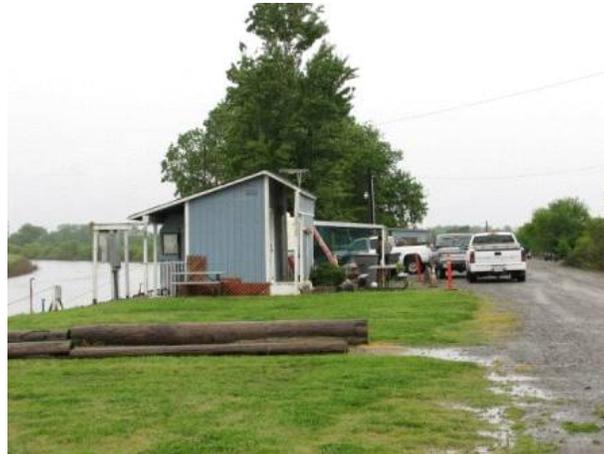
johngw_f_20131021_038.jpg

The Yacht club is on the crown. Fall 2013

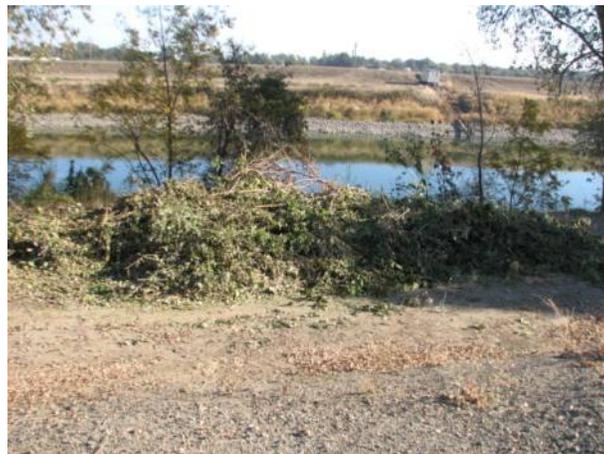
johngw_f_20131028_260.JPG

Levee Mile Report Line	19
Start Levee Mile	0.66
End Levee Mile	0.66
Location	Water Side
Category	Earthen Levee
Item	Encroachments

A large pruning pile placed on the waterside berm. Fall 2013

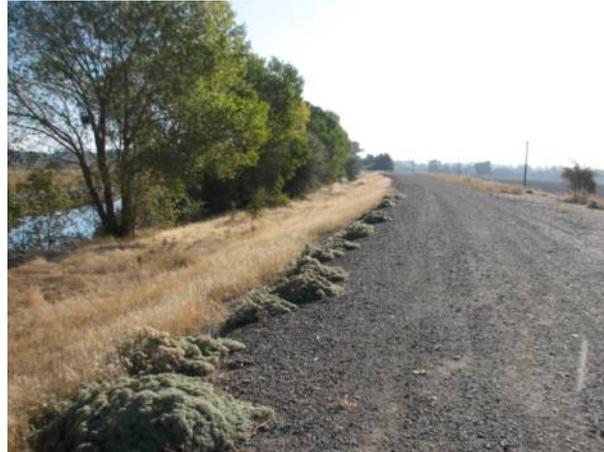
Levee Mile Report Line	20
Start Levee Mile	0.72
End Levee Mile	5.90
Location	Water Side
Category	Earthen Levee
Item	Vegetation
Tall grasses partially block visibility. Fall 2013	
johngw_f_20131028_262.JPG

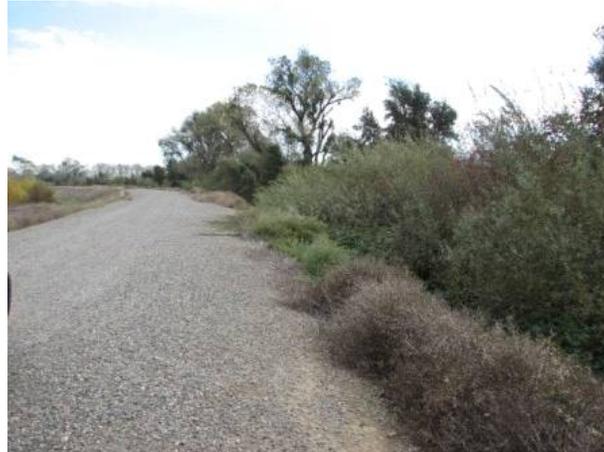
Levee Mile Report Line	23
Start Levee Mile	0.97
End Levee Mile	1.14
Location	Land Side
Category	Earthen Levee
Item	Vegetation
The vegetation completely blocks the view of the levee slope. Fall 2011	
johngw_f_20131021_036.jpg

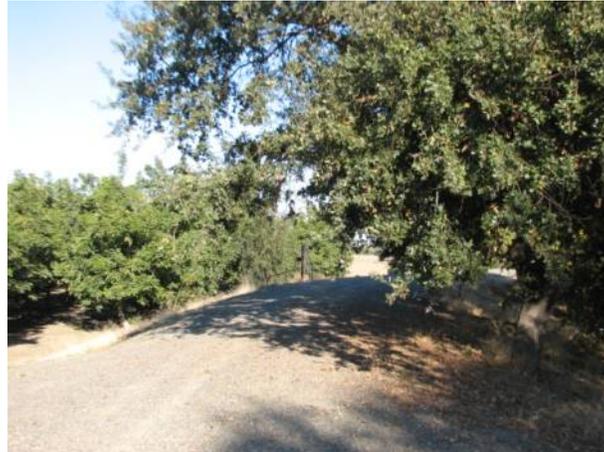
Levee Mile Report Line	26
Start Levee Mile	1.83
End Levee Mile	1.83
Location	Crown
Category	Earthen Levee
Item	Trim / Thin Trees
Trees need to be trimmed up to 12 feet above the crown. Fall 2013	
johngw_f_20131028_264.JPG

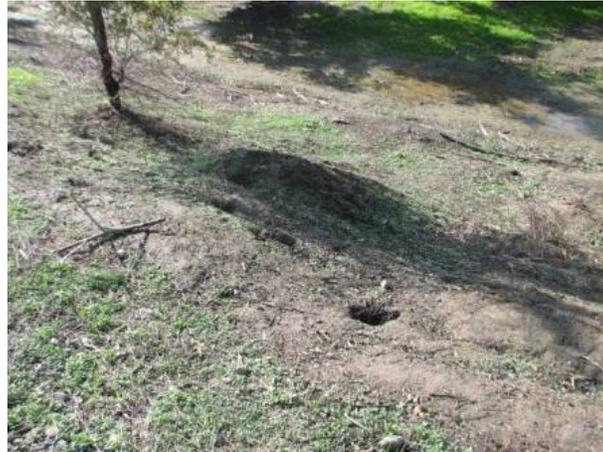
Levee Mile Report Line	28
Start Levee Mile	2.03
End Levee Mile	2.03
Location	Land Side
Category	Earthen Levee
Item	Animal Control
Many rodent hole in this location on the slope. Fall 2012	
johngw_f_20131021_019.jpg

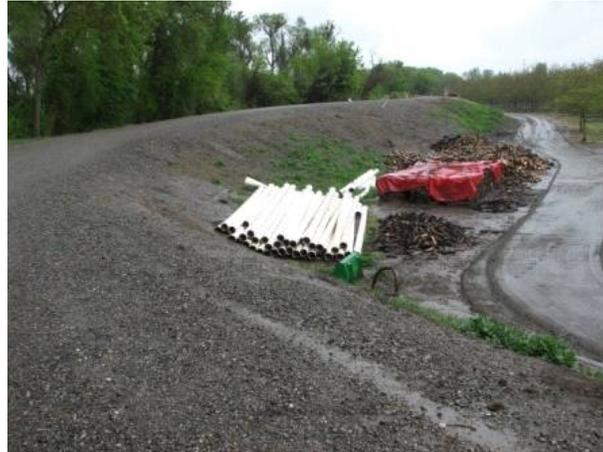
Levee Mile Report Line	31
Start Levee Mile	2.22
End Levee Mile	2.22
Location	Land Side
Category	Earthen Levee
Item	Encroachments
Pipe along toe.	
johngw_f_20131021_054.jpg

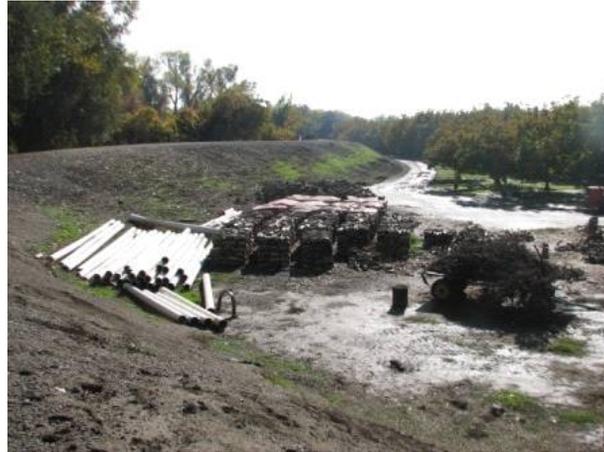
johngw_f_20131021_053.jpg

The firewood pile is continuing to grow along the toe of the levee. Fall 2012

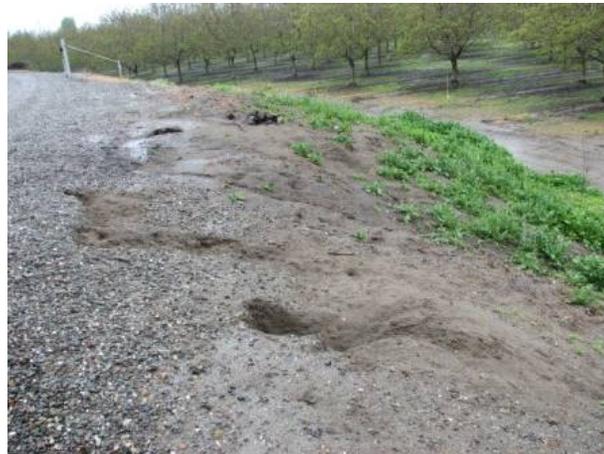
johngw_f_20131021_055.jpg

Levee Mile Report Line	34
Start Levee Mile	2.25
End Levee Mile	2.25
Location	Land Side
Category	Earthen Levee
Item	Animal Control

Rodents

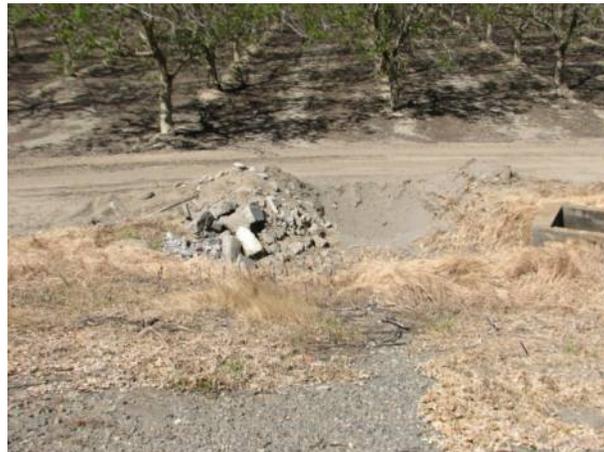
johngw_f_20131021_058.JPG

Levee Mile Report Line	35
Start Levee Mile	2.39
End Levee Mile	2.39
Location	Land Side
Category	Earthen Levee
Item	Encroachments

Concrete debris is at the toe of the levee. Spring 2013

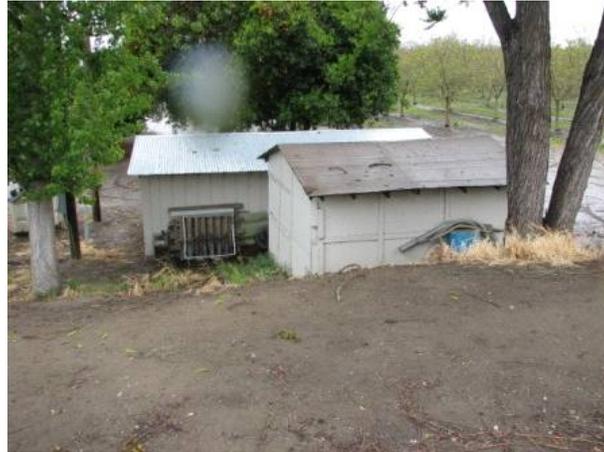
Levee Mile Report Line	36
Start Levee Mile	2.62
End Levee Mile	2.62
Location	Land Side
Category	Earthen Levee
Item	Encroachments
Garage at toe.	
johngw_f_20131021_025.jpg

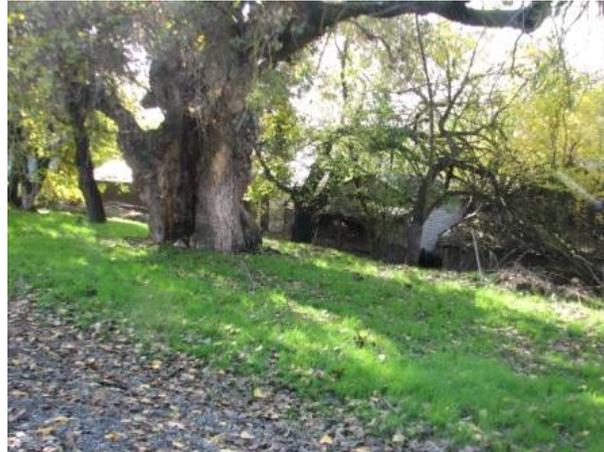
Levee Mile Report Line	40
Start Levee Mile	3.12
End Levee Mile	3.19
Location	Land Side
Category	Earthen Levee
Item	Encroachments
Buildings are located at the toe of the levee. Fall 2012	
johngw_f_20131021_027.jpg

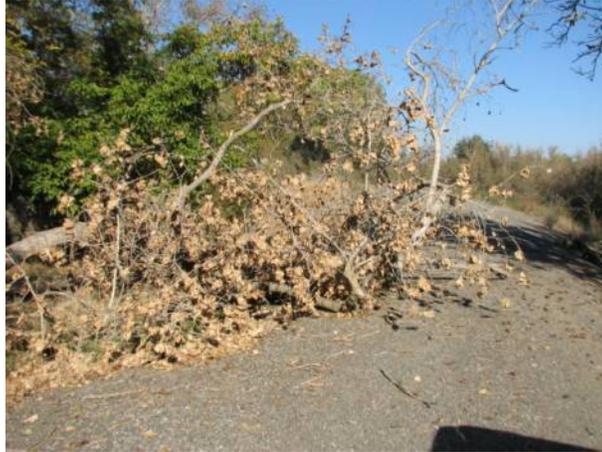
Levee Mile Report Line	42
Start Levee Mile	3.13
End Levee Mile	3.13
Location	Crown
Category	Earthen Levee
Item	Encroachments
A tree has fallen on the crown of the levee. Fall 2013	
johngw_f_20131028_266.JPG

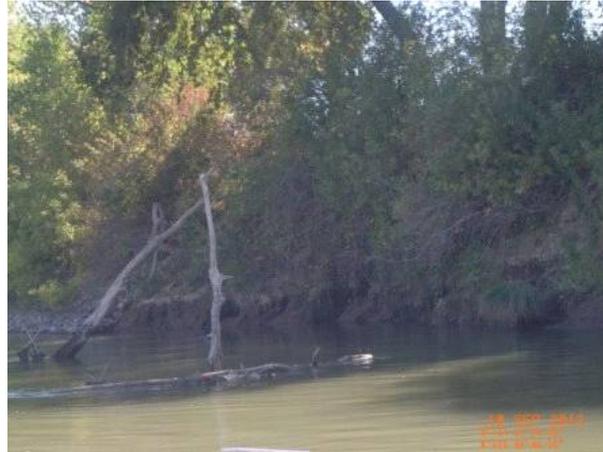
LMIR No.	Levee Mile		Category	Item	Location	Rating	Action/Comment	GPS Latitude/Longitude		Issue No. Photo
	Start	End						Start	End	
43	3.18	3.28	Supplemental	USACE Erosion Survey	WS	M Ma	Inspector Comments: 2006 - Short section is into the levee toe, rest is near the levee toe. Mass failure and fluvial erosion of depositional material. Rock at the upstream and downstream ends. 2011 - Minor new erosion. 2012: No observed change. [2012 Site ID: SAC_86-9_R]	38.780407 ° -121.688238 °	38.779137 ° -121.687432 °	3 Y
DWR ID:										
44	3.25	3.25	Earthen Levee	Trim / Thin Trees	WS	M Ma	T3 : Trim and thin trees to allow visibility of the ground and room to flood fight. Inspector Comments: Dead tree broken during winter storms needs to be cleaned up.	38.780041 ° -121.688499 °	38.780041 ° -121.688499 °	15 Y
DWR ID: DWR_NA0022_01_s_2012_15										
45	3.31	3.31	Earthen Levee	Trim / Thin Trees	WS	M Ma	T3 : Trim and thin trees to allow visibility of the ground and room to flood fight. Inspector Comments: Fallen tree from winter storms, needs to be cleaned up.	38.779352 ° -121.688041 °	38.779352 ° -121.688041 °	16 Y

Levee Mile Report Line	43
Start Levee Mile	3.18
End Levee Mile	3.28
Location	Water Side
Category	Supplemental
Item	USACE Erosion Survey
USACE 2012 Photo #3	
USACE2013_SAC_86-9_R_3.jpg

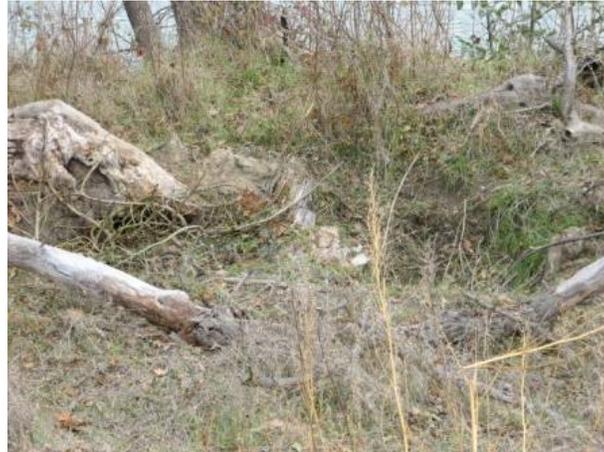
Levee Mile Report Line	45
Start Levee Mile	3.31
End Levee Mile	3.31
Location	Water Side
Category	Earthen Levee
Item	Trim / Thin Trees
<p>This is the root ball of the tree. It has created a large void in the berm. Fall 2011</p> <p>johngw_f_20131021_030.jpg</p>

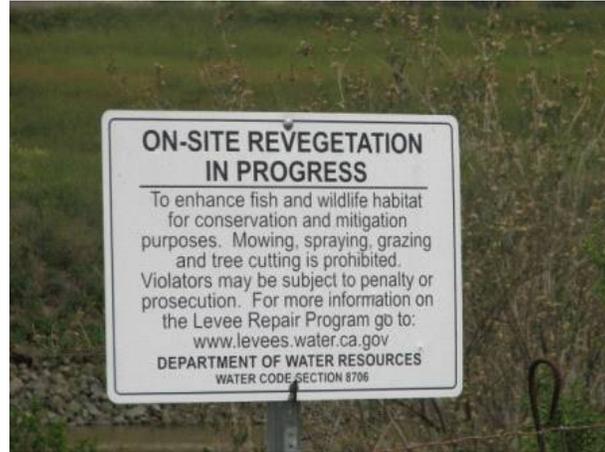
johngw_f_20131021_049.jpg

USACE revegetation site photo spring 2012.

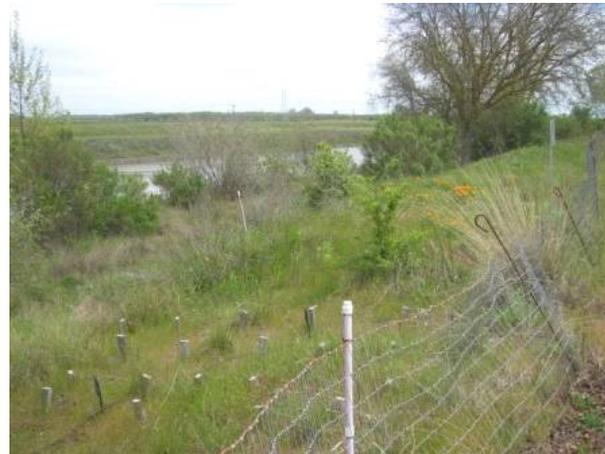
johngw_f_20131021_050.jpg

Levee Mile Report Line	48
Start Levee Mile	4.31
End Levee Mile	4.57
Location	Water Side
Category	Earthen Levee
Item	Vegetation

Fence, irrigation and stakes in the revegetation site.

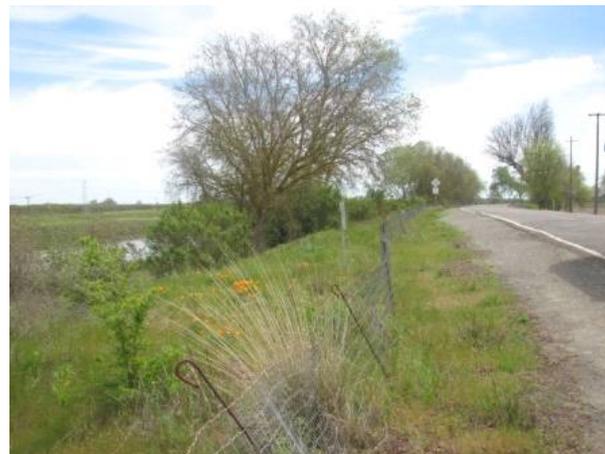
johngw_f_20131021_051.jpg

Levee Mile Report Line	48
Start Levee Mile	4.31
End Levee Mile	4.57
Location	Water Side
Category	Earthen Levee
Item	Vegetation

Another view of the site.

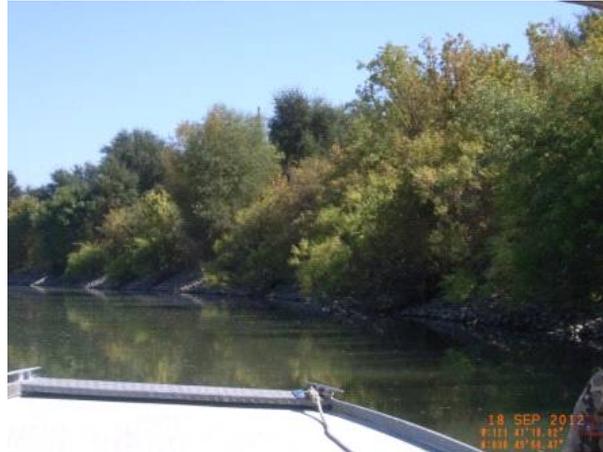
Levee Mile Report Line	49
Start Levee Mile	4.66
End Levee Mile	4.86
Location	Water Side
Category	Supplemental
Item	USACE Erosion Survey
USACE 2012 Photo #1	
USACE2013_SAC_85-4_R_1.jpg

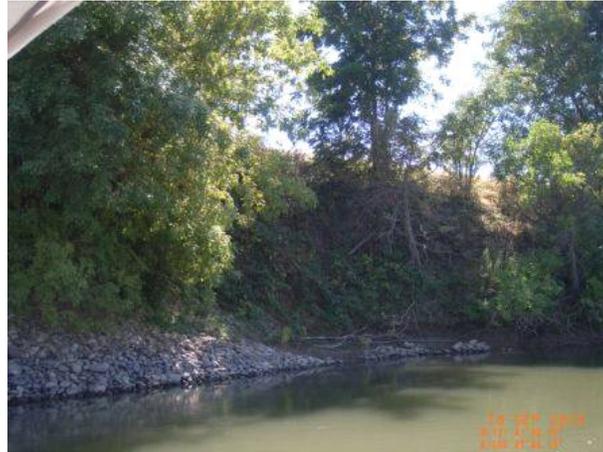
Levee Mile Report Line	49
Start Levee Mile	4.66
End Levee Mile	4.86
Location	Water Side
Category	Supplemental
Item	USACE Erosion Survey
USACE 2012 Photo #4	
USACE2013_SAC_85-4_R_4.jpg

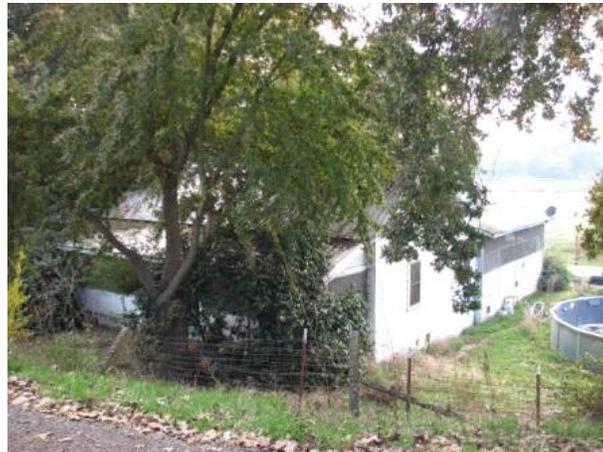
Levee Mile Report Line	50
Start Levee Mile	5.60
End Levee Mile	5.65
Location	Land Side
Category	Earthen Levee
Item	Encroachments
The house and landscape are in the easment of the levee. Fall 2011	
johngw_f_20131021_004.jpg

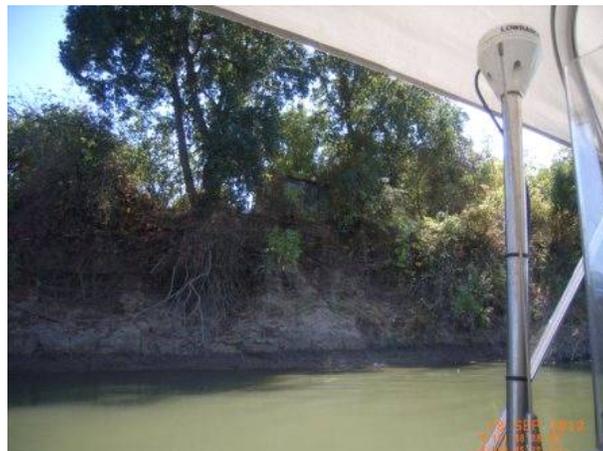
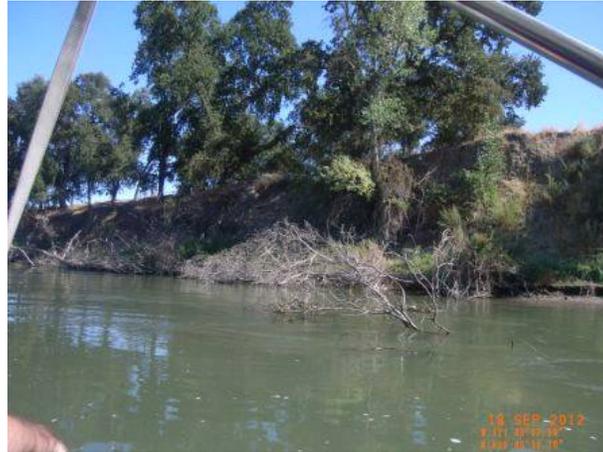
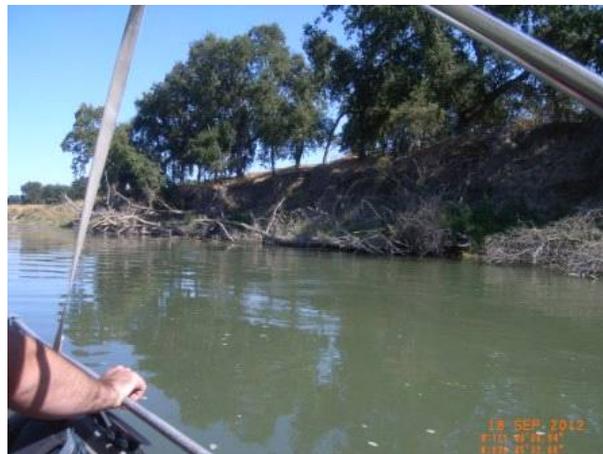
DWR ID: DWR_NA0022_01_s_2012_1										
51	5.77	5.86	Supplemental	USACE Erosion Survey	WS	M Ma	Inspector Comments: 2006 - Approximately 18 to 20 ft of bank near levee at the corner of the levee and the Freemont Weir. Vertical bank with undercutting/mass failure. 2007 - Staked at top of bank for monitoring. 2011 - Site has become significantly worse with more of the toe and lower bank eroded. Many trees have fallen since last year. 2012: Site looks worse with more erosion around trees. [2012 Site ID: SAC_83-9_R]	38.758877 ° -121.669365 °	38.759390 ° -121.667500 °	5 Y
DWR ID:

Levee Mile Report Line	51
Start Levee Mile	5.77
End Levee Mile	5.86
Location	Water Side
Category	Supplemental
Item	USACE Erosion Survey
USACE 2012 Photo #1	
USACE2013_SAC_83-9_R_1.jpg

Levee Mile Report Line	51
Start Levee Mile	5.77
End Levee Mile	5.86
Location	Water Side
Category	Supplemental
Item	USACE Erosion Survey
USACE 2012 Photo #2	
USACE2013_SAC_83-9_R_2.jpg

Levee Mile Report Line	51
Start Levee Mile	5.77
End Levee Mile	5.86
Location	Water Side
Category	Supplemental
Item	USACE Erosion Survey
USACE 2012 Photo #3	
USACE2013_SAC_83-9_R_3.jpg
